Reference: Existing barn structural inspection
7 Worcester Road in Washington, Connecticut

BARN PHOTOS MAY 5, 2021
#7 WORCESTER ROAD WASHINGTON, CONNECTICUT

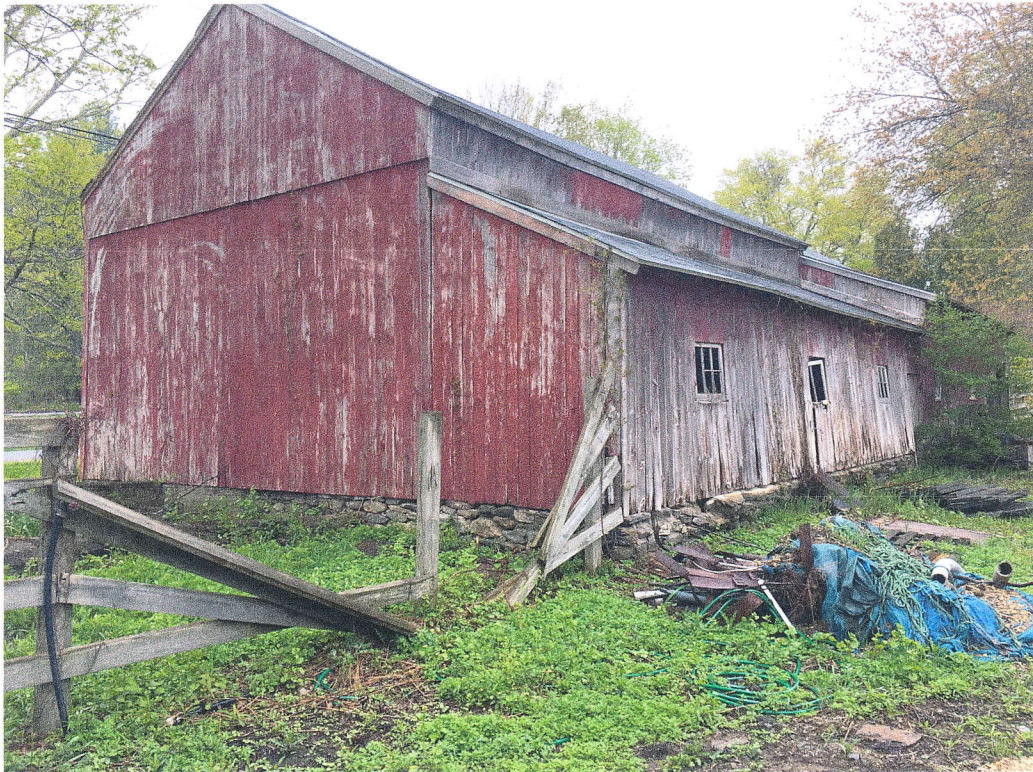
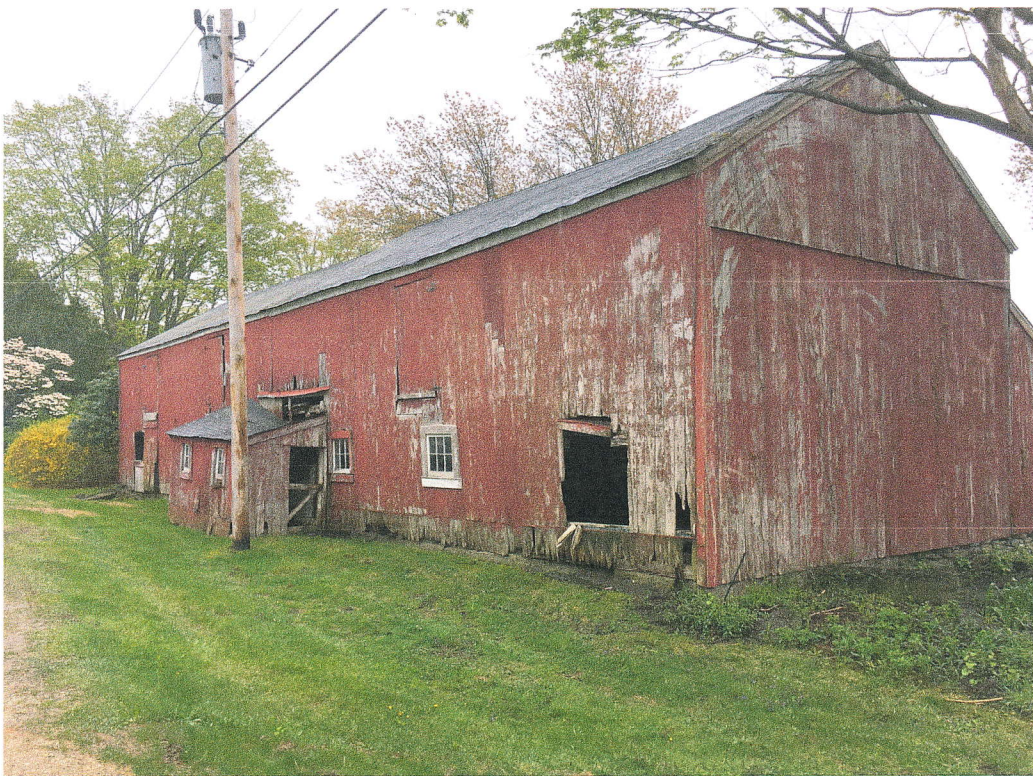
At your request, I conducted an inspection of the existing barn structure at the Durrett residence at 7 Worcester Road. Attached are two pages of photos showing the exterior and interior of the building. The barn is in the northwest corner of the lot and the north wall extends directly along the property line adjacent to Worcester Road. The Tax Assessor field card for the property lists the year built as 1860, which appears consistent with the field stone foundation walls and post & beam framing. There is significant settling and movement of the foundation walls, which indicate the support structure does not extend below the Building Code required minimum footing depth of 42" below finish grade. The concrete floor slab has numerous cracks and deflection due to freeze/thaw conditions. Some post and beam framing members have been replaced and the upper floor is partially supported by temporary jacking posts. From my inspection, I would rate the current barn structure as in poor condition. My recommendation is to dismantle the existing wood framing and salvage the timbers and boards that are not rotted or insect damaged. A new concrete foundation with footings and walls constructed according to Building Code standards is definitely required to provide support for a reconstructed barn.
